iFlight Thunder H7 Instructions

Firmware:
 Betaflight: 2RAW_THUNDER.H7
 INAV: 2RAW_THUNDER.H7

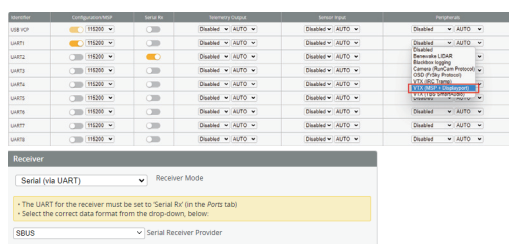
DJI Digital Transmitters: SUBS Protocol

Firmware Target: 2RAW_THUNDER.H7

- To enable the air unit OSD under Betaflight 4.4 version, you need to select VTX (MSP+Displayport) in the peripheral port where the air unit signal is connected to the port interface.
- Please check your protocols, otherwise your DJI Radio won't input signals!
 DJI Goggle protocol and Betaflight protocol has to match!
 For lower signal latency use the SBUS BAUD_FAST protocol option on both ends.
- For Betaflight Copy Paste "set sbus_baud_fast=on" into your Betaflight Configurator CLI then hit enter.
 Use "save" and hit enter to save the changes.
 Default: sbus_baud_fast=off, Goggle protocol set to NORMAL
